Center for Independence of the Disabled, NY

Curb Cut Survey Report: Analysis of June 4, 2014 Curb Cut Surveys in Lower Manhattan

June 4, 2014 Curb Cut Survey Report

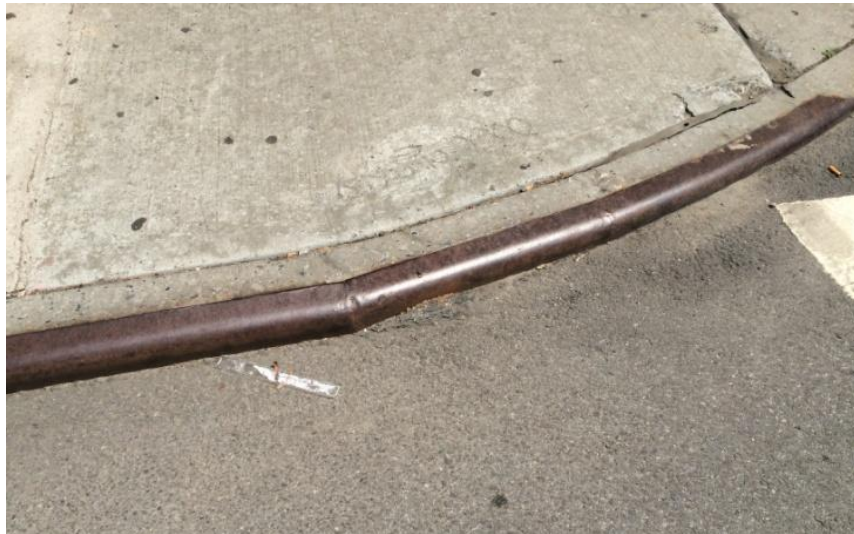
Delancey Street, Lewis Street
No curb cut.

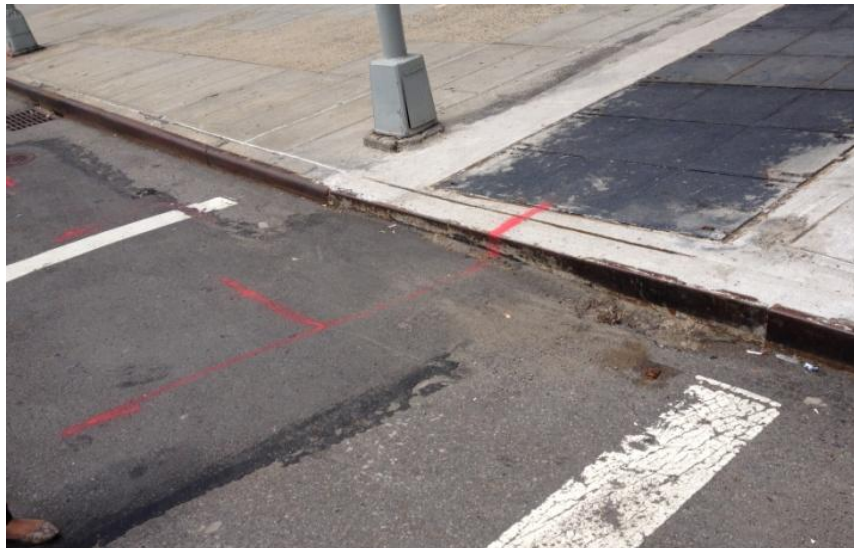
Pearl Street, Beekman Street
No curb cut.

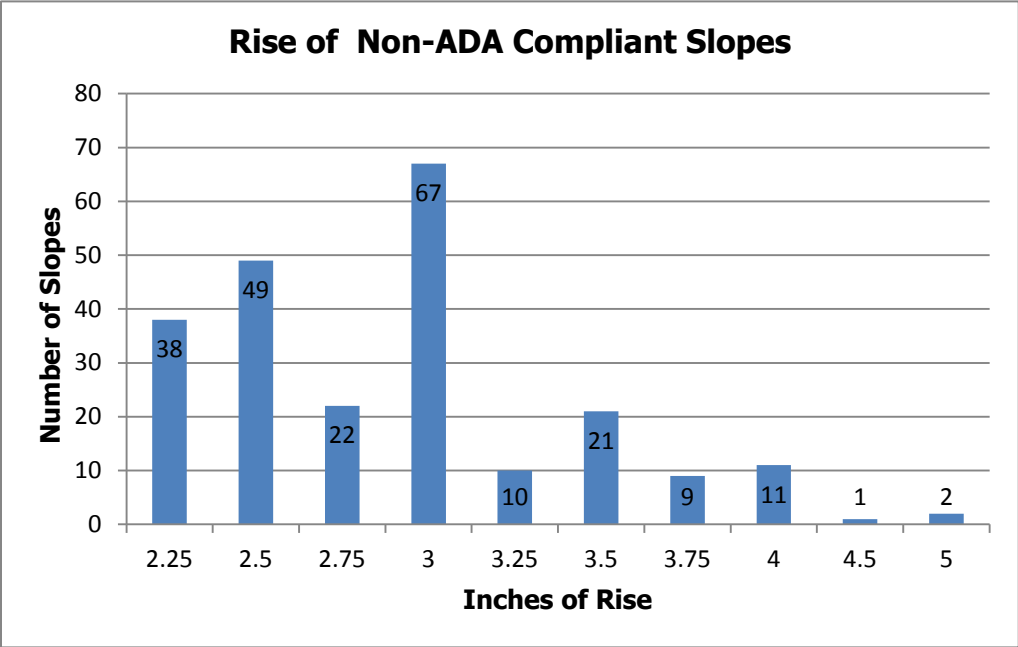
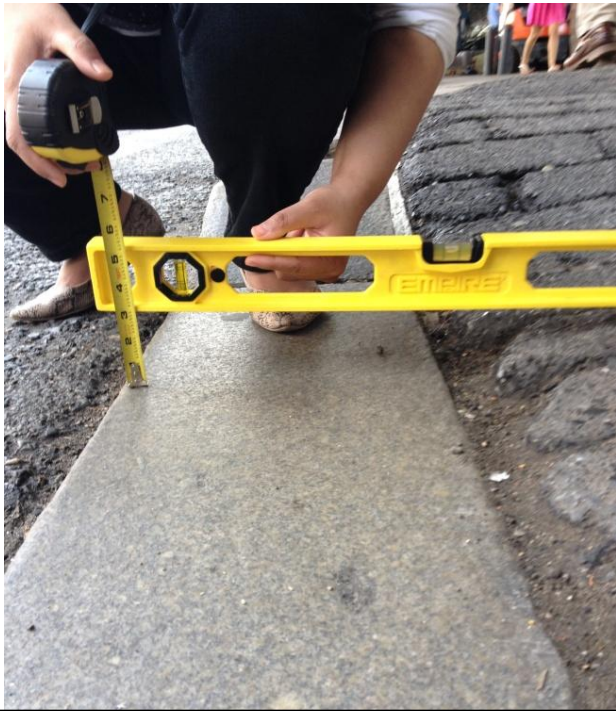
South Street, Fulton Street
Slope ratio – 3":24".

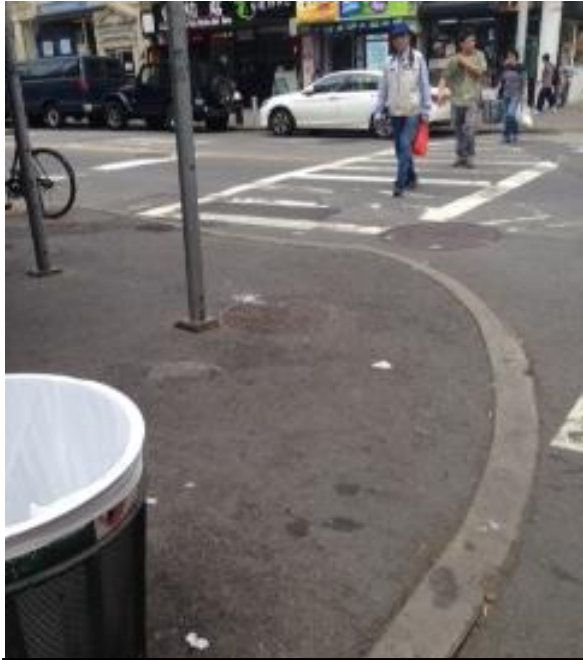
Eldridge Street, Canal Street
No Real Cuts.

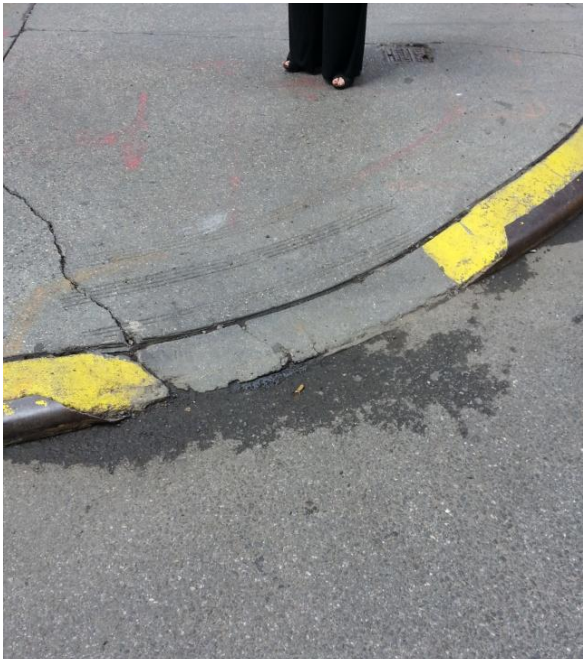
Broad Street, Stone Street
Cut is 36" wide, but does not have a level 36in cut.

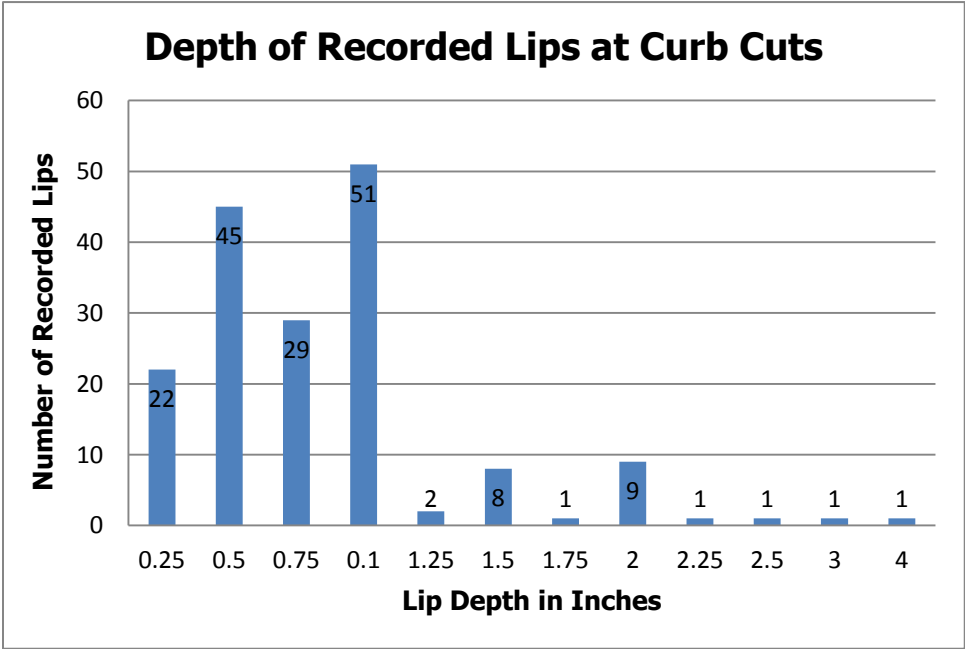
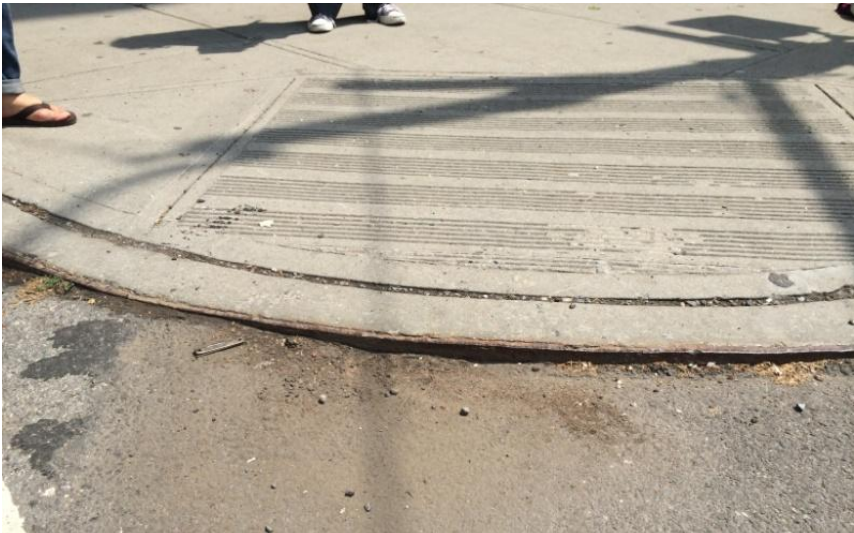
Delancey Street, Lewis Street
0.5 inch lip.

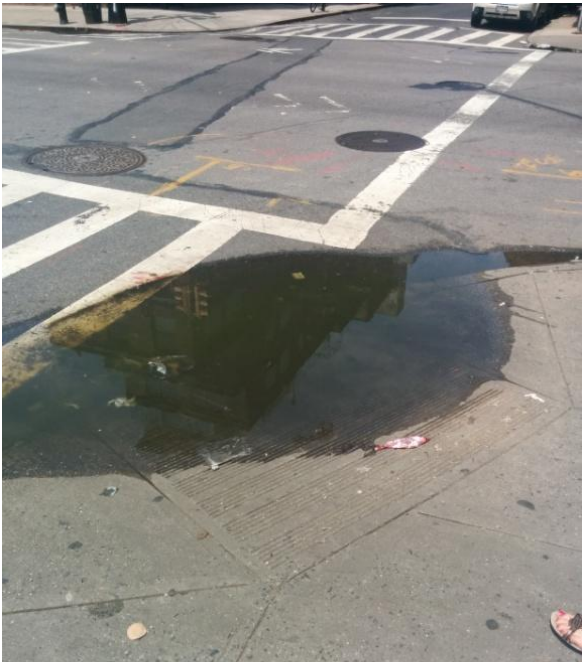
Grand Street, Ludlow Street
Large puddle pooled at curb cut;
Lip at curb cut.

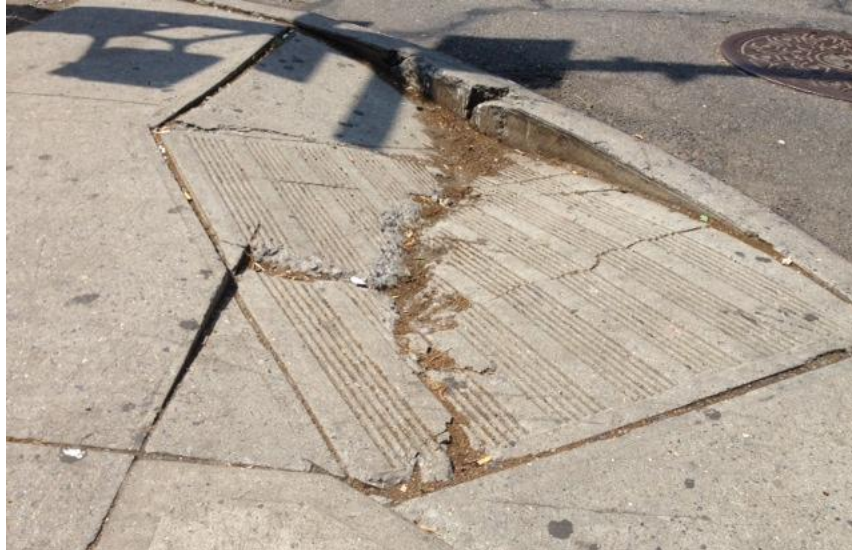
Broome Street, Ludlow Street
Severely deteriorated concrete causing depression in curb cut surface and 4 inch lip.

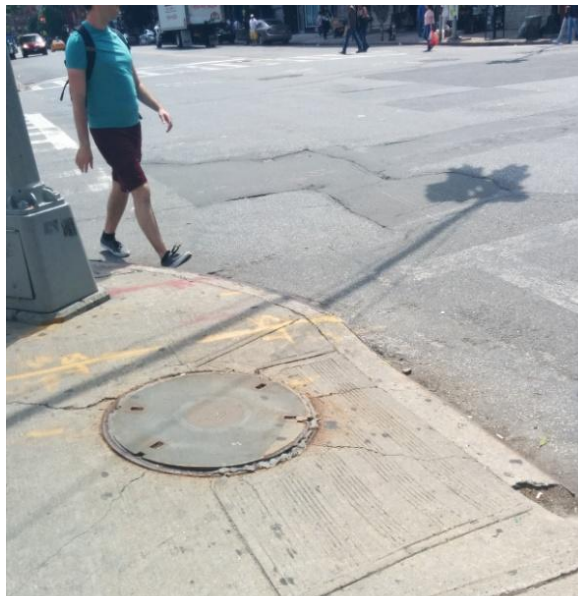
Grand Street, Essex Street
Cracks in concrete surface, deteriorated concrete at base of ramp, and manhole cover in curb cut.

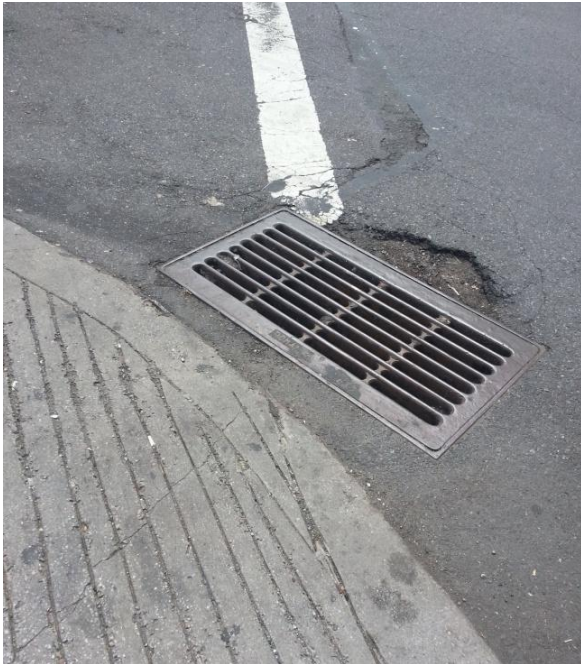
Baxter Street, Bayard Street
Grate at base of curb cut that leads directly to pot hole.

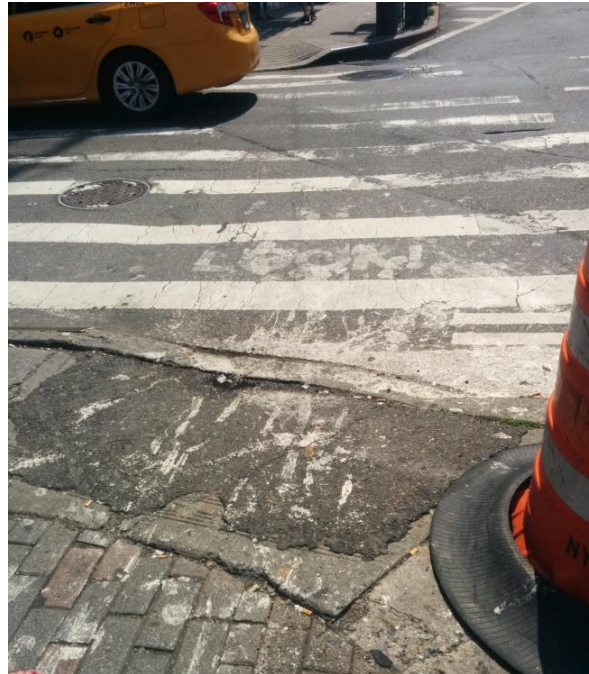
Clinton Street, Delancey Street
Asphalt used to cover deteriorating surface.

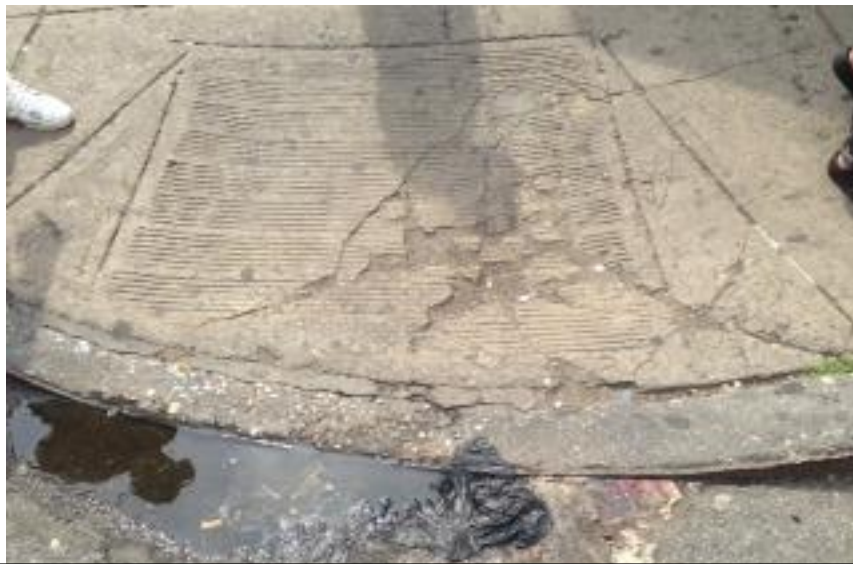
Rutgers Street, Madison Street
Crumbling concrete leading to pot hole and pooled water.

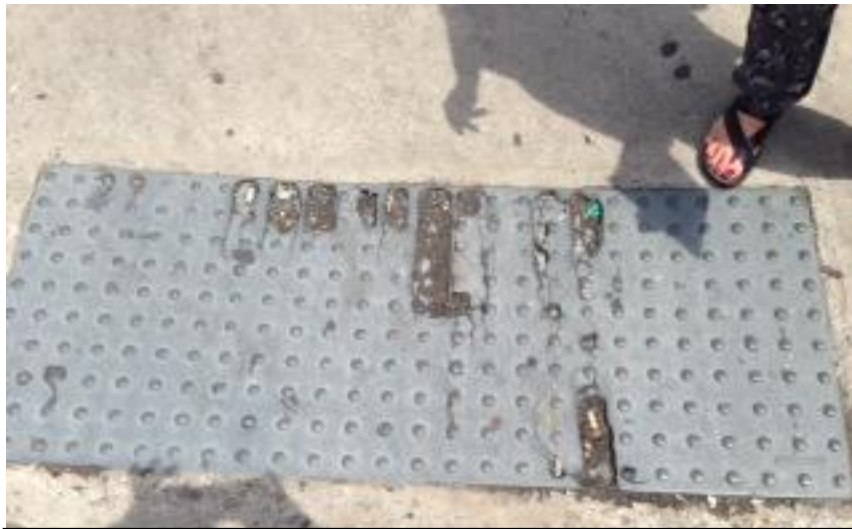
**Pike Street, East Broadway
Crumbling truncated domes.**

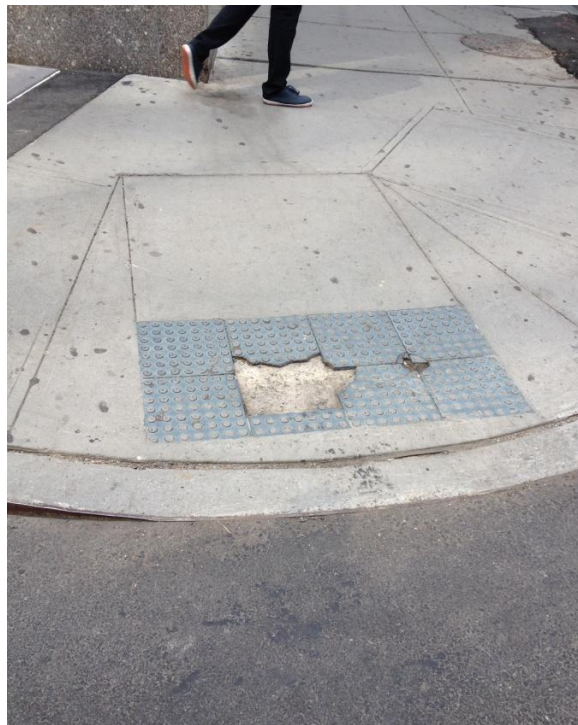
**John Street, Pearl Street
Missing plate of truncated domes.**

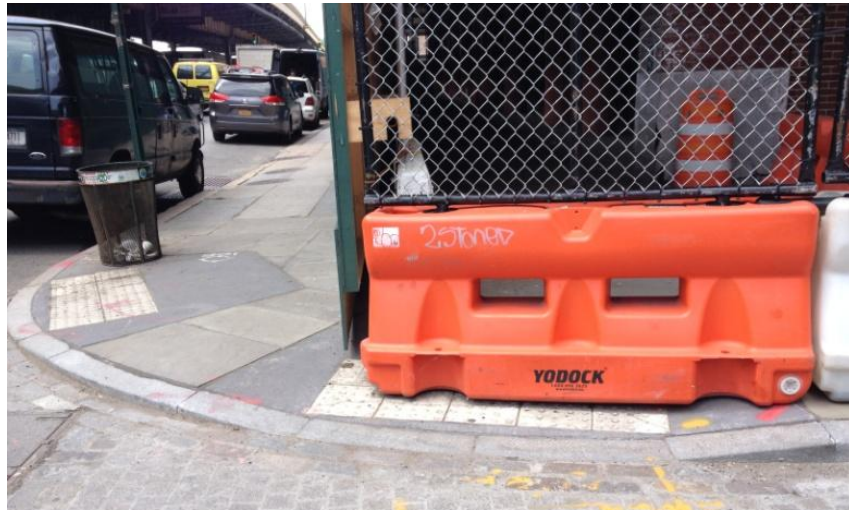
South Street, Beekman Street
Construction in barrier completely blocking passage of curb cut.

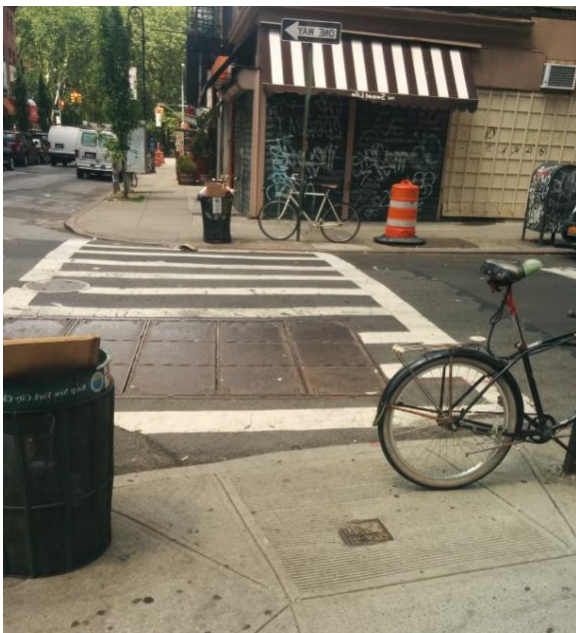
Ludlow Street, Hester Street
Bike locked to street sign pole,
narrowing clearance of curb cut ramp.

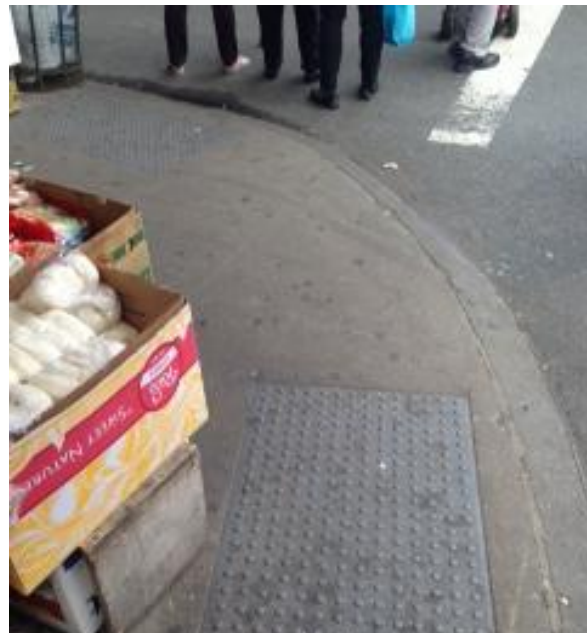
Forsyth Street, East Broadway
Merchants' products placed on street,
providing no clearance at cut.

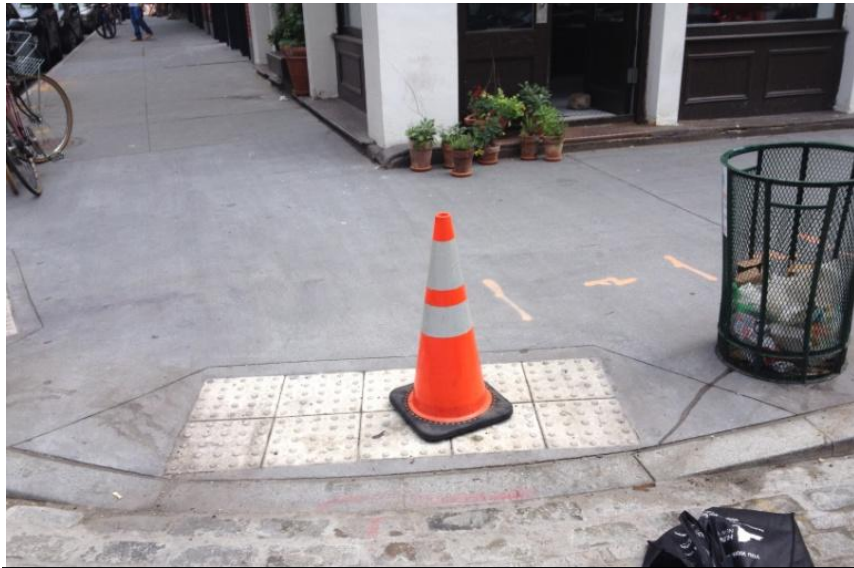
Water Street, Peck Slip
Construction cone placed in curb cut.

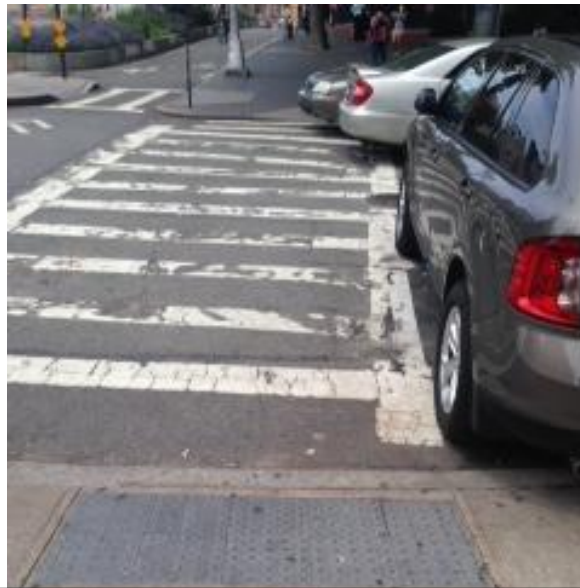
Forsyth Street, Canal Street
Cars parked at curb cut extend into path of travel narrowing cut at one corner and making impassible at opposite corner.

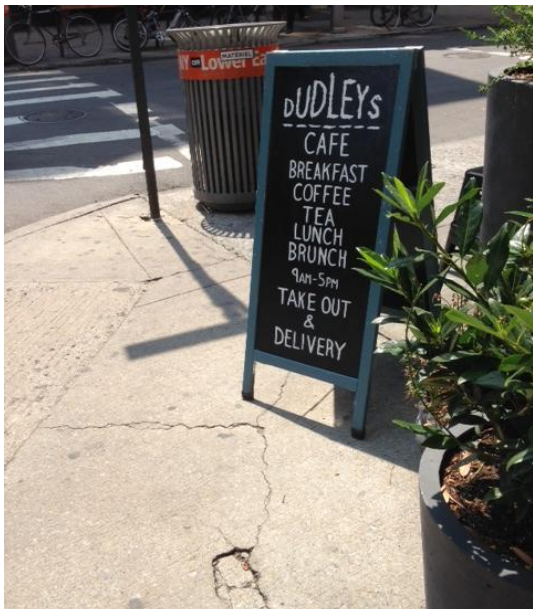
Orchard Street, Broome Street
Café sandwich board sign and planters obstruct route to curb cut.

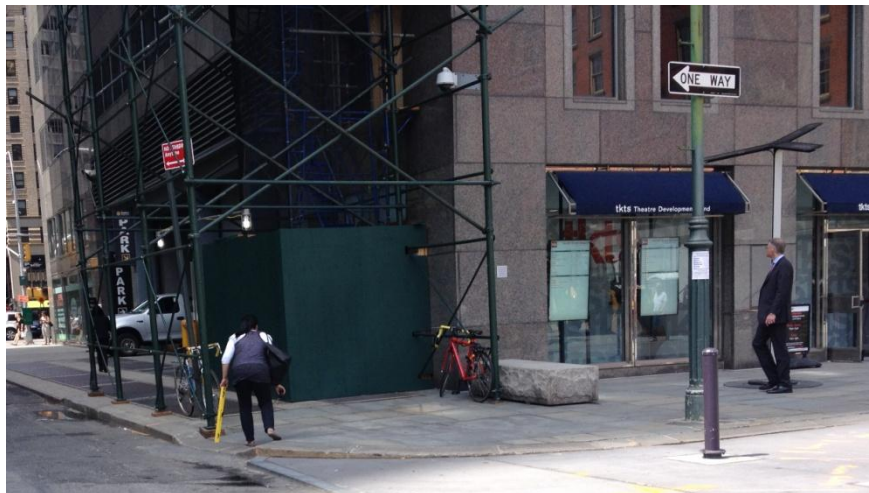
Front Street, John Street
Scaffolding and construction narrow pathway on sidewalk. Bikes locked to scaffolding further narrow the pathway.

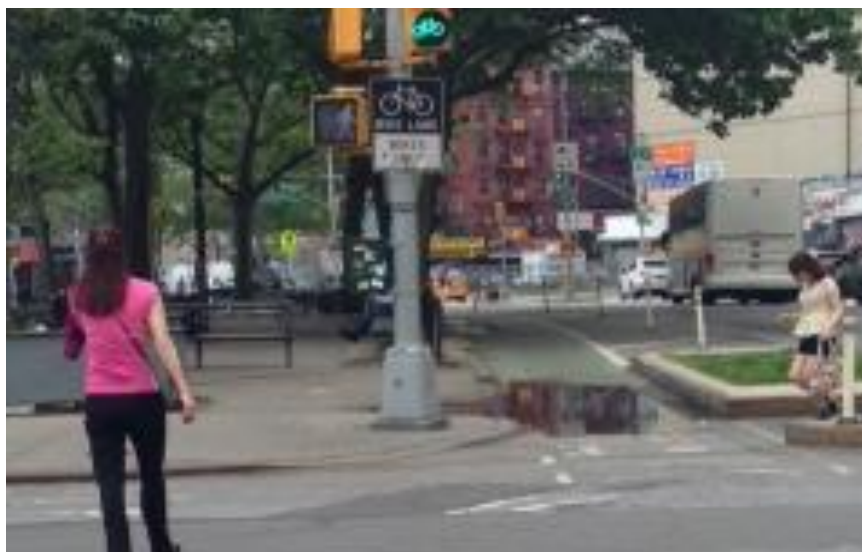
Allen Street, Canal Street – Center Island
Bike lane crosses directly in front of curb cut opening.

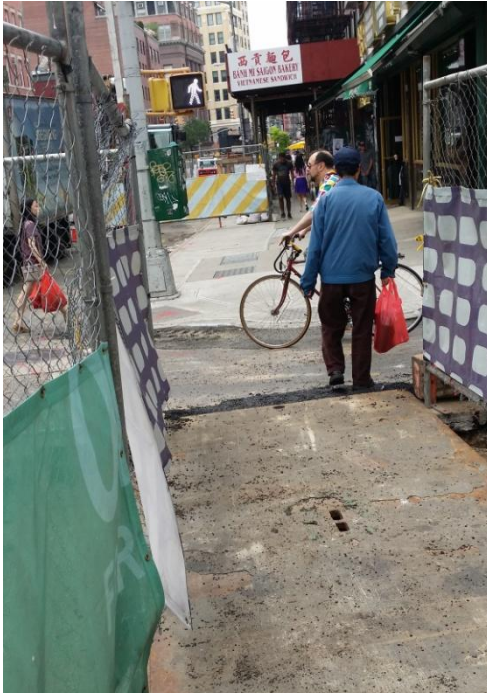
Mulberry Street, Grand Street
Temporary pathway with uneven surface in middle of street between path from one cut to the next.

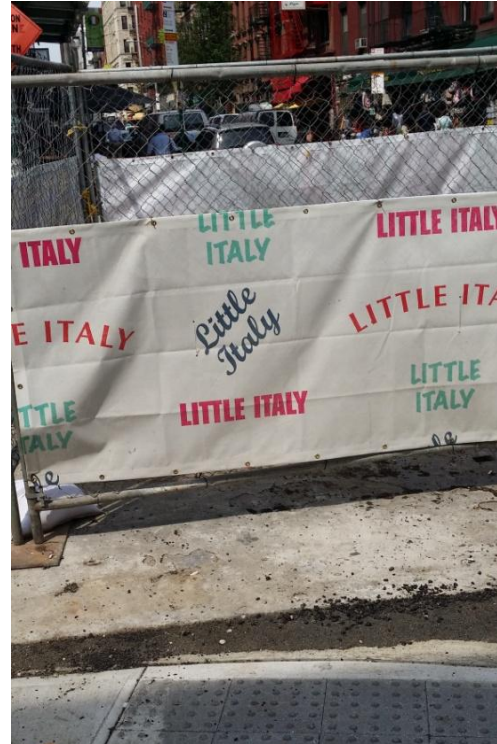
Mulberry Street, Grand Street –
Fences from street fair block access to curb cut and street.

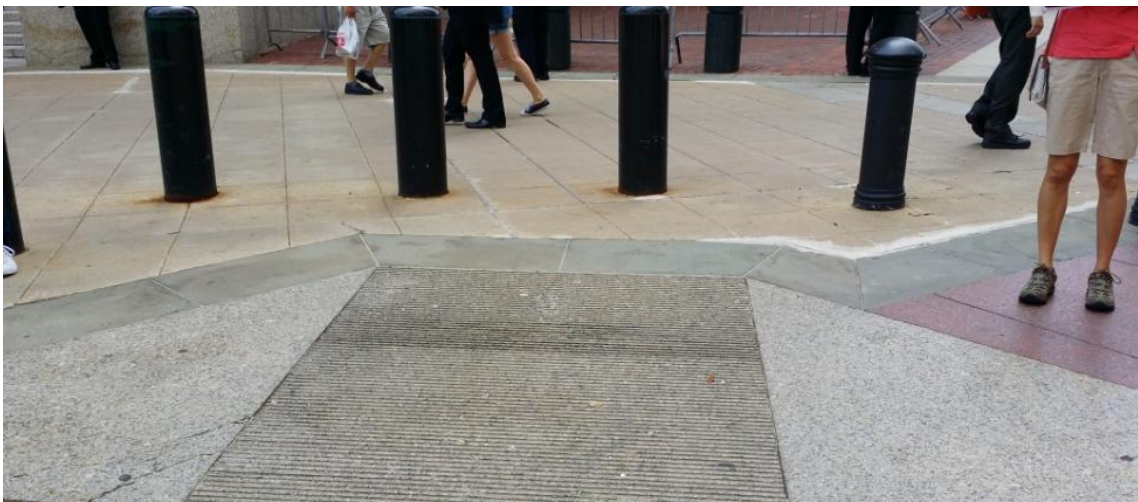
Centre Street, Chambers Street
Concrete pillars block access to curb cut. These types of pillars were reported at several curb cuts.
