## Manhattan

Photo 1- PS 206 Manhattan –Not enough clearance space at landing.

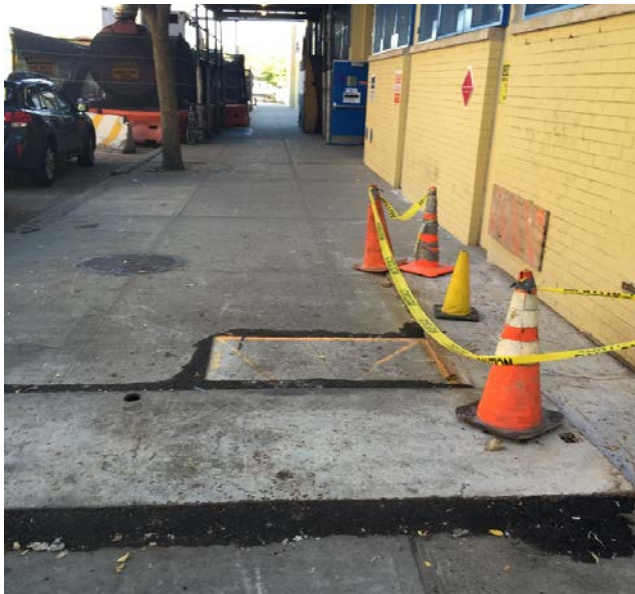
Photo 2 -PS 206 Manhattan- Path to main entrance.

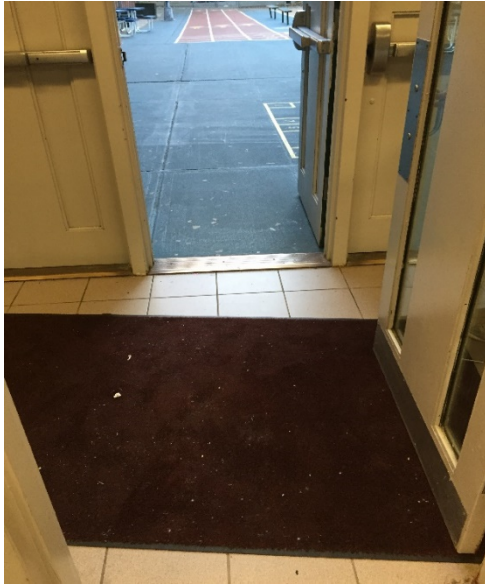
### Measuring the entry

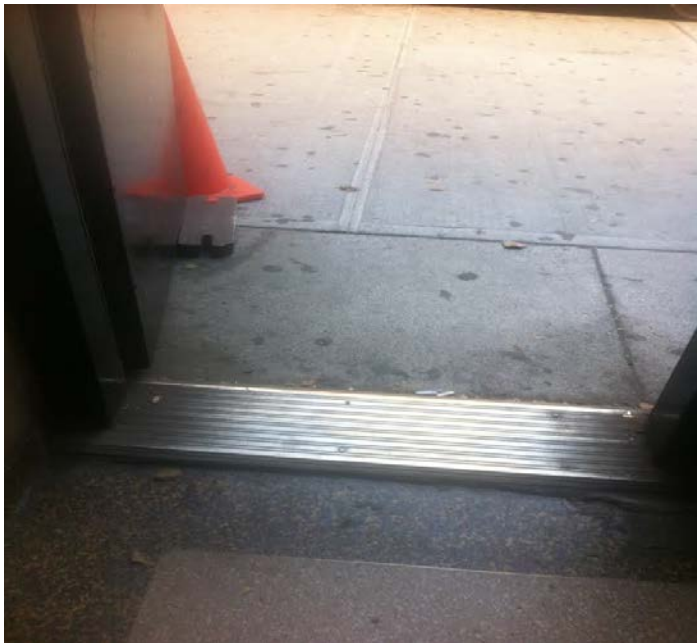
Photo 6- Bayard Rustin, Manhattan - Cone and object used to keep door open.

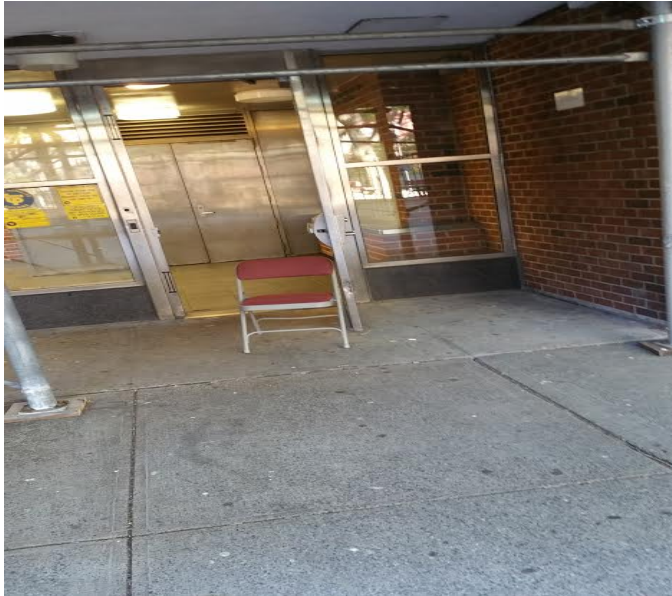
Photo 7- Max Meltzer Community Center Manhattan- Chair used to hold door open.

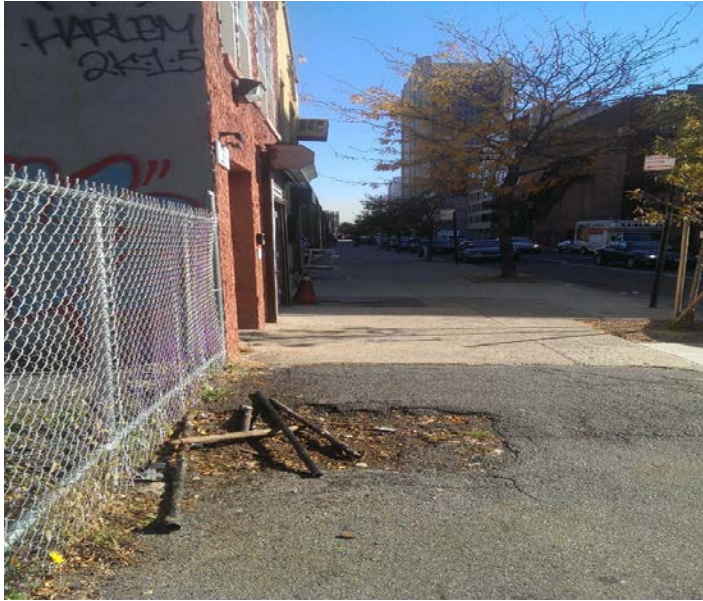
Photo 9- PS 154, Manhattan – Broken, uneven sidewalk with debris on path to alternate entrance.

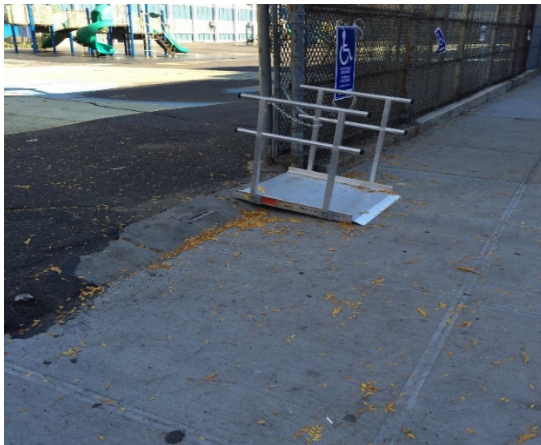
Photo 10- PS 154 Manhattan - Temporary ramp at alternate entrance with lip 1 1/2" high and landing on broken sidewalk.

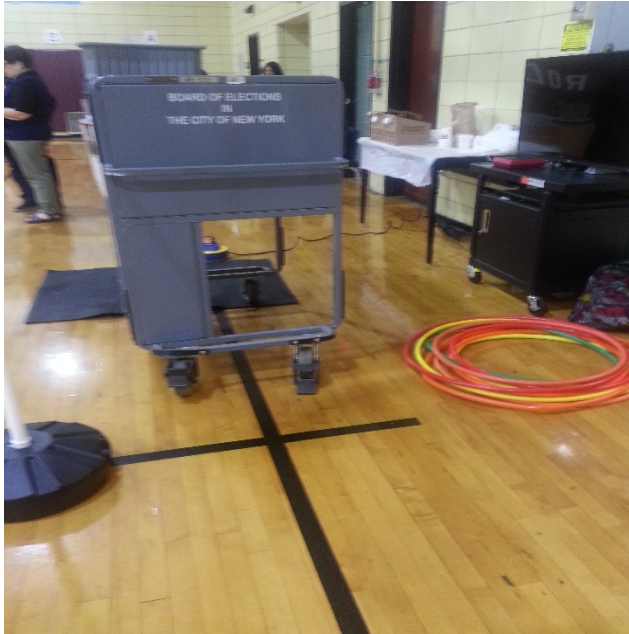
Photo 11- East New York High School Brooklyn – BMD spacing

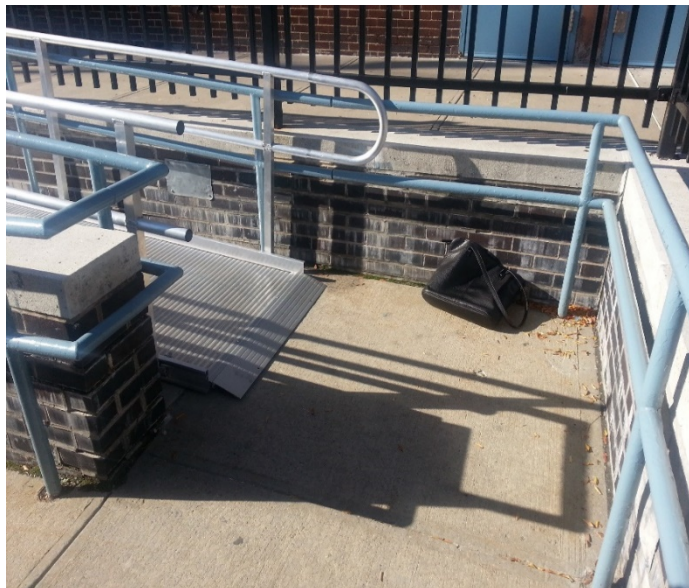
Photo 15- PS 224 Brooklyn- Bevel at entrance of ramp is too steep.

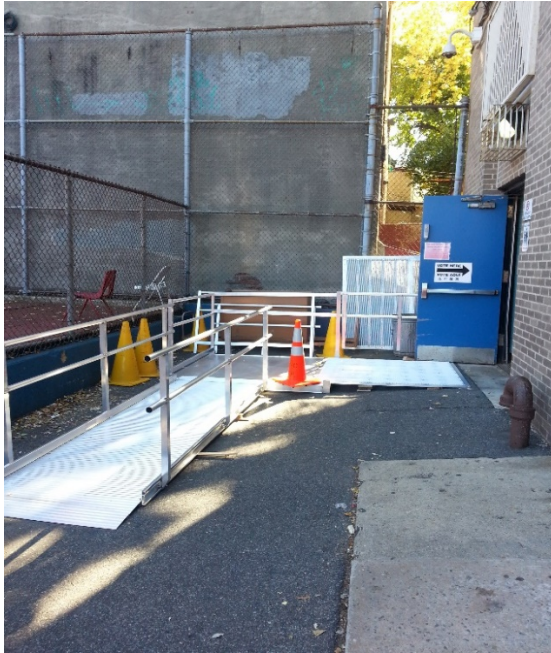
Photo 17- PS 290 – The ramp has missing handrails.

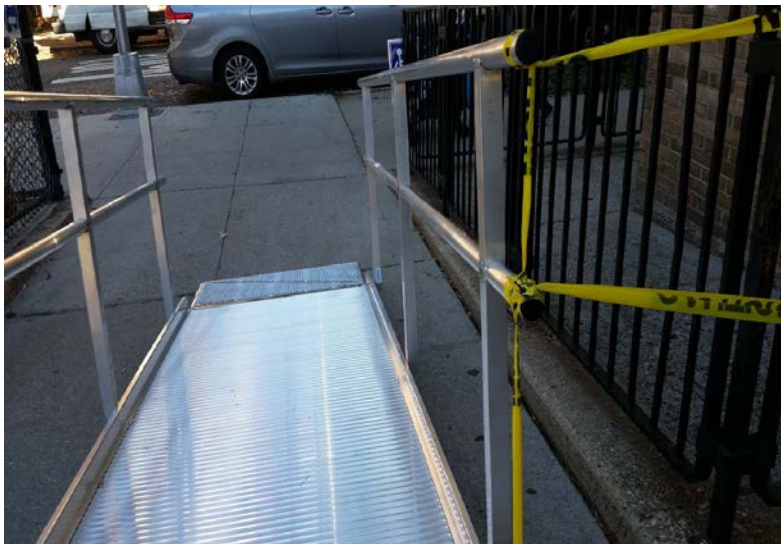
Photo 18 -PS 321 Brooklyn - This ramp is poorly constructed with missing handrails on both sides.

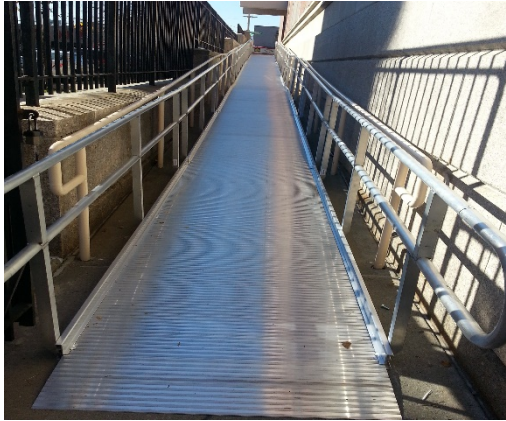
Photo 19 - WH Career Tech PS 60, Brooklyn— Ramp has no landing

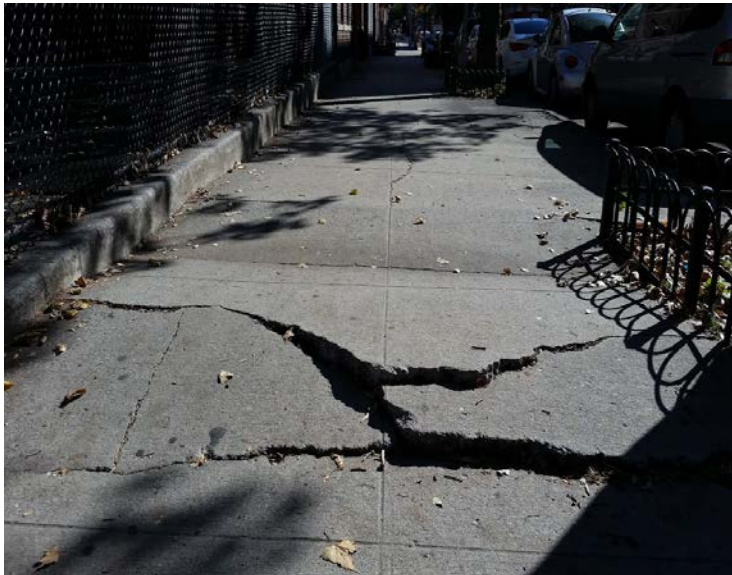
Photo 20- PS 38 Brooklyn – Broken sidewalk on pathway to alternate entrance.

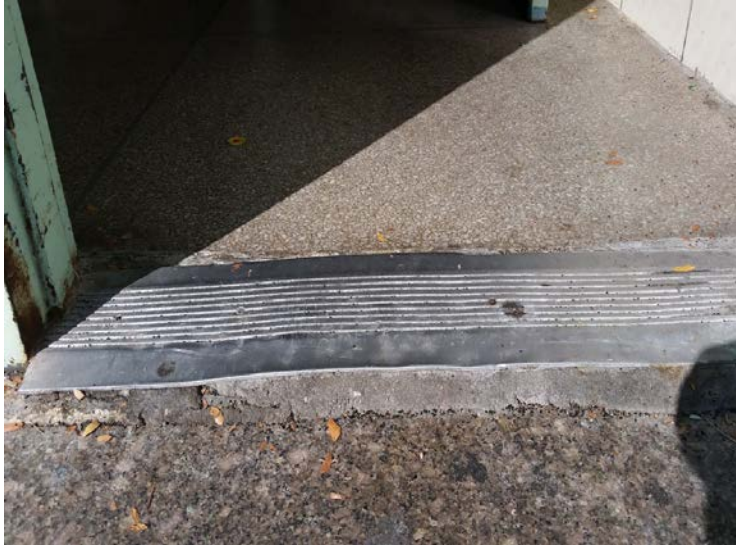
Photo 21- PS 38 Lip at accessible entrance was badly beveled and approximately 2 inches high.

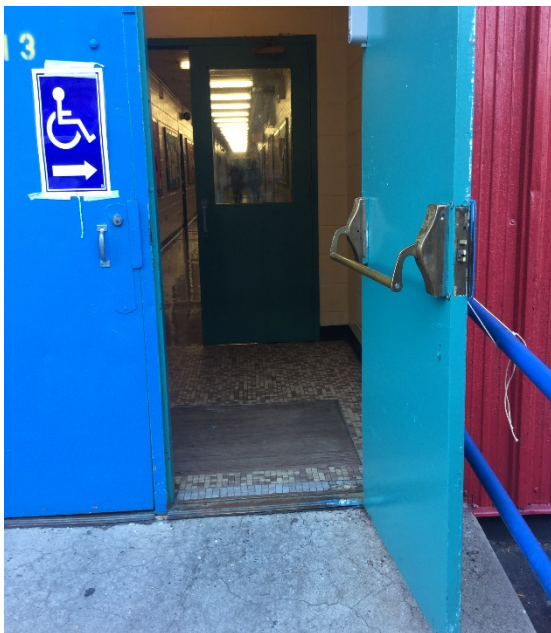
Photo 22-PS 53, Bronx - Door way is 27" wide.

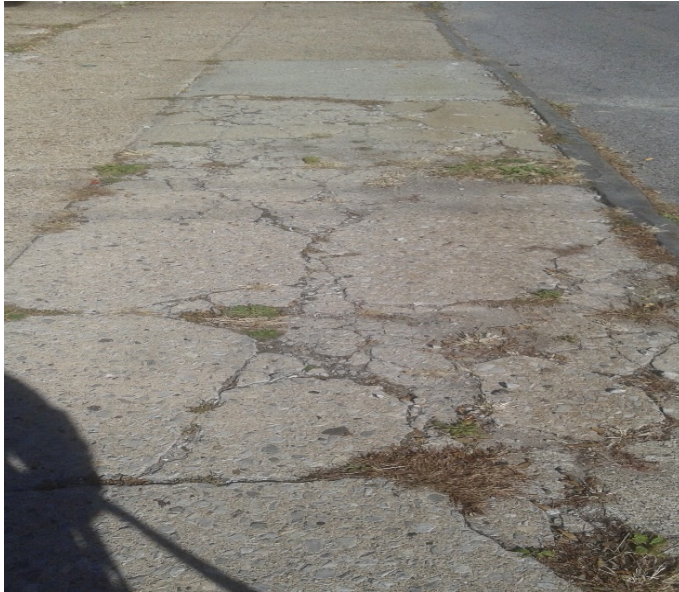
Photo 25- Summerfield Church, Staten Island –Broken pathway.

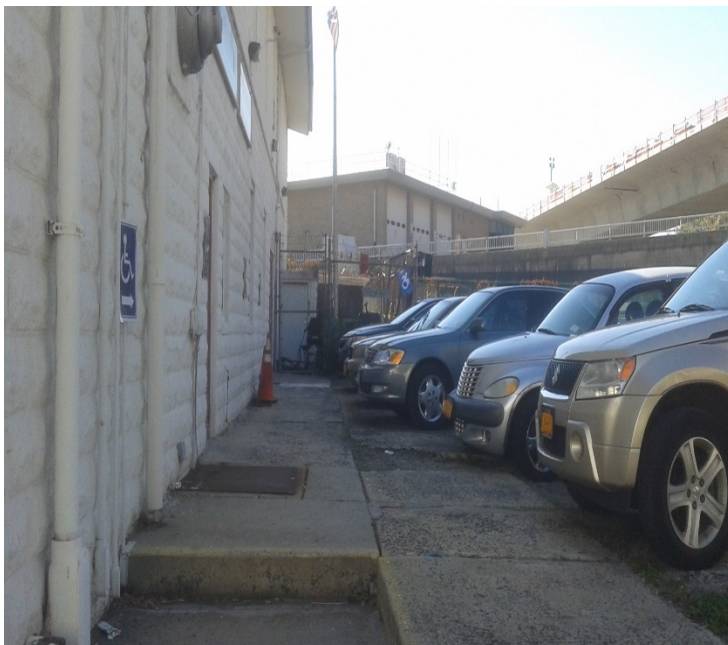
Photo 26- American Legion Staten Island – Doorway has a 1.5" lip and pathway to accessible entrance uneven. The path to the accessible entrance is through a gravel parking lot with spots of grass which is difficult for people who use mobility aids and wheelchair users to navigate. There are also several tripping hazards that are not marked for people who are blind. People who are blind and use canes may not register the large drop on the left in this picture until they are already tripping off the sidewalk.
