November General Election 2016: Voters with Disabilities Still Blocked from Voting Independently and Privately As the Law Requires

CIDNY teams surveyed a total 64 sites during the November 8, 2016 General Election. Of the 64 sites surveyed only 14, or 22 percent, were without barriers.

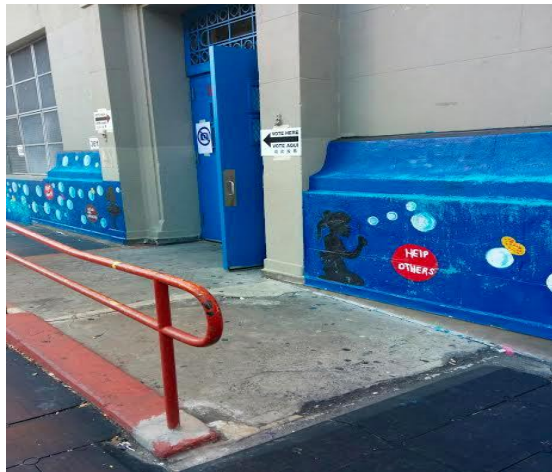
This ramp is non-ADA compliant. The lip was 1/5" high and there were several cracks on cemented ramp creating tripping hazards. Also difficult for those using wheelchairs to maneuver around cracks and over lip.

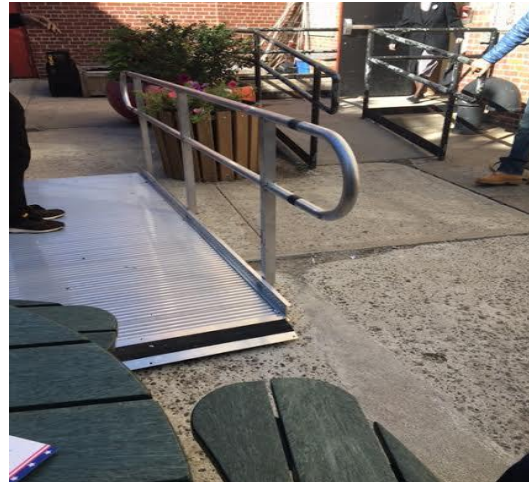
Photo 3: Fiorello La Guardia HS of the Performing Arts - Lip to ramp was 1" high. ADA standard is $\frac{1}{2}$ " so people using wheelchairs can ride over lip and not a tripping hazard for those who are blind or low vision.

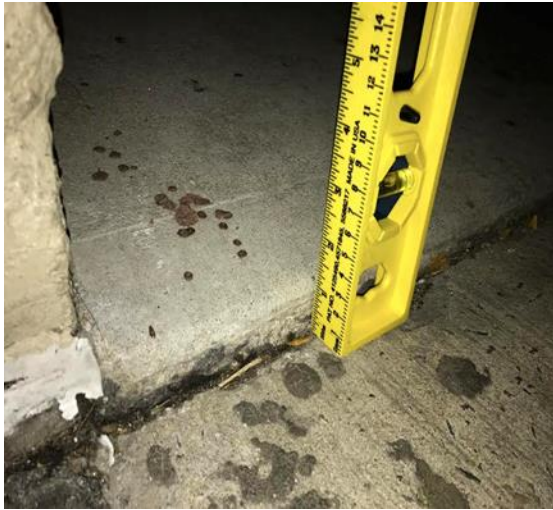
Photo 4: PS 282 - Ramp had gap at doorway, ramp was $32\frac{1}{4}$ inches, door was $31\frac{1}{2}$ inches with door latch. ADA standard is 32" to allow those using wheelchairs and scooters to enter.

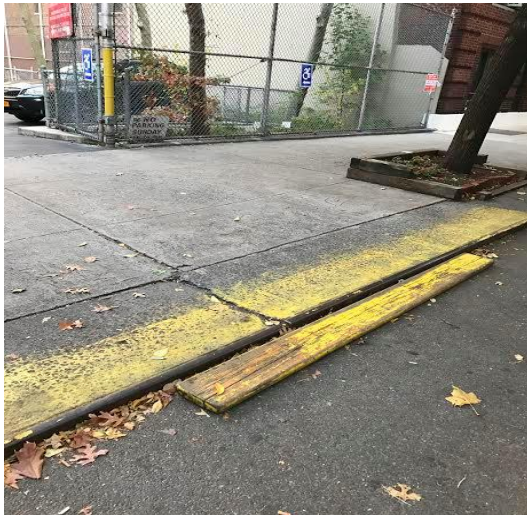
Photo 6: JHS 56 - Broken, uneven sidewalk at accessible entrance is tripping hazard and creates barrier for someone using wheelchair or scooter.

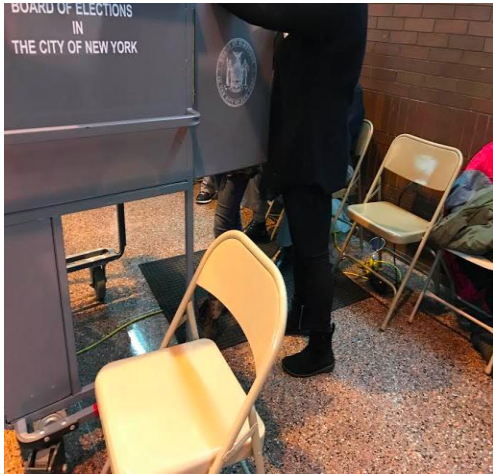
Photo 14: PS 87 – Chairs and pizza boxes blocking access to BMD, ADA standard requires 5' clearance for wheelchair users.

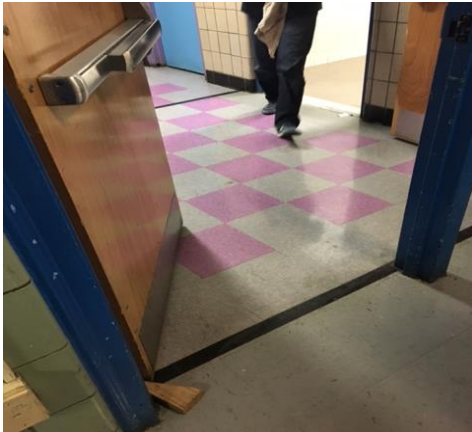
Photo 17: Fiorello H. LaGuardia HS - doorway measures 30" wide; ADA standard is 32" to allow access to wheelchair and scooter users.

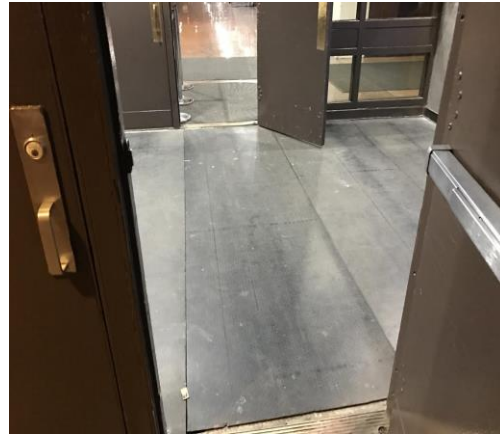
Photo 18 & 19: IS 218 - Cords across entryway created a tripping hazard for those who are blind or low vision and barrier for those using wheelchairs that may get caught up in cord. Was corrected by placing mat over it after surveyors notified coordinator.

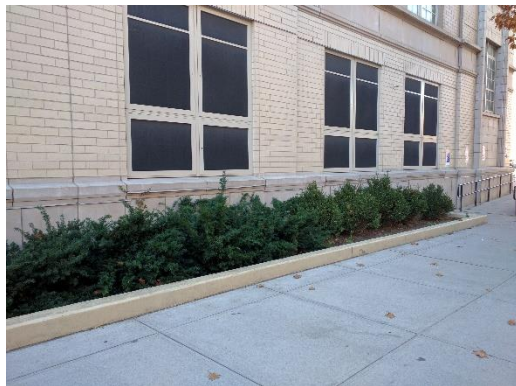
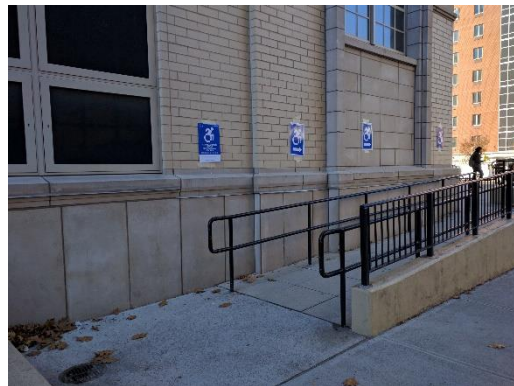
Photo 22 & 23: P.S. 133 - No directional signs on street leading to accessible entrance until at the ramp, then 4 in a row at ramp. ADA requires accessibility signs along the route to the accessible entrance so that voters can be assured of the accessible entrance.
