Center for Independence of the Disabled, NY

Special Election, February 24, 2009 - Poll Site Accessibility Notes

During the Special Election on February 24, 2009, CIDNY visited seven poll sites throughout Senate District 15 to assess compliance with standards set by the Help America Vote Act (HAVA) and the ADA. CIDNY noted improvements at several sites such as the placement of new, large, durable directional accessible entrance signs and wireless doorbells systems, as pictured below. In addition, the Ballot Marking Devices were set up at every site we visited. However, the following summaries of the sites visited describe barriers, both physical and attitudinal, still faced by voters with disabilities. Poll workers at nearly every site revealed that there is a tremendous need for training on the BMDs and disability awareness.

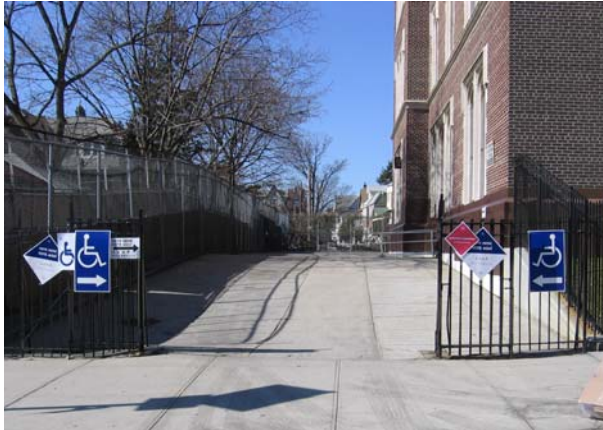
PS 64, Joseph P. Addabbo School

1. The entrance had heavy doors and no bell for someone to request assistance.
2. The elevator provides access to the poll site on the second floor for individuals with mobility impairments. The door clerk said that the elevator has broken down almost every election in the past three years. There were lawn mowers stored in front of the elevator in such a way that there was not the 36" clearance required by the ADA. The principal was notified and said she would ask the janitor to move them. She also mentioned that the elevator broke down during elections.
3. The poll worker trained on the BMD was out for lunch. Another poll worker said that they were told not to offer the BMD to voters.

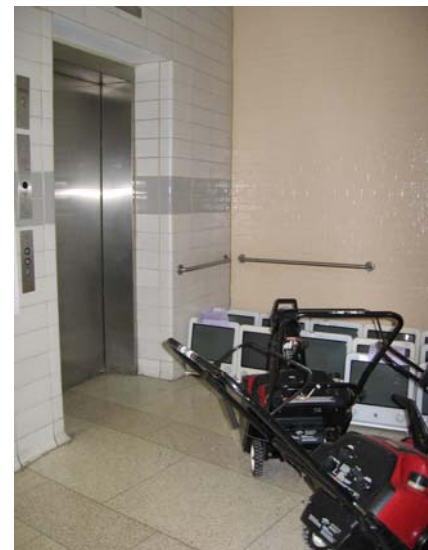
4. Along the pathway to the BMD, there was a place where tables and chairs narrowed the route to less than 36". When this was pointed out, poll workers made more room. This is an example of the need for more poll worker training.

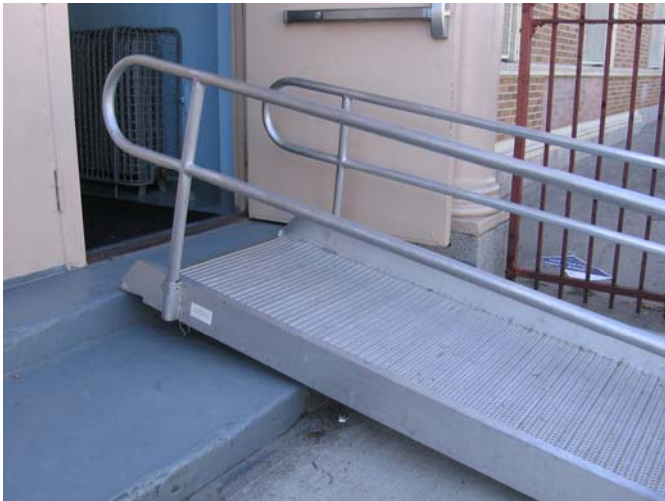
PS 63

1. The ramp to the entrance was too steep. The 6 foot long ramp was made for a 6 inch rise but had an 11 inch rise. The BOE was contacted about this and later informed CIDNY that the site did not use the Poll Room designated by the BOE, and therefore deviated from the accessible pathway that the BOE had selected for this site.
2. The poll worker said that the policy regarding informing voters about the BMDs is, "don't ask, don't tell."

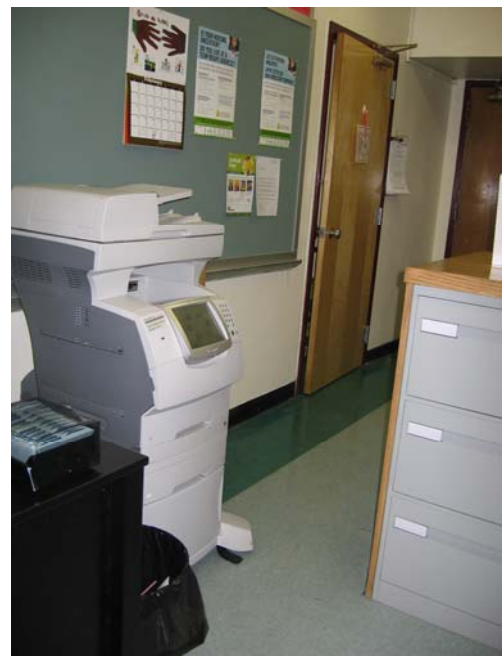
PS 202 JHS

1. Initially, there were no signs to direct voters from the main entrance to the alternate, accessible entrance. BOE workers arrived around 3PM and put up clear, large and durable accessible entrance signage.
2. There was a 2 inch lip at the start of the ramp, impeding access for someone using a wheelchair or scooter.
3. Initially, there was no way for a voter at the accessible entrance to request assistance negotiating the heavy entrance door. The door monitor was inside and said it was too cold to stay outside. The BOE workers that arrived around 3PM installed a doorbell system.
4. The path from the accessible entrance to the voting area led through an office. The pathway around the office counter was narrowed by the placement of a copy machine. The space was much too narrow for someone using a wheelchair to get through (see photo).

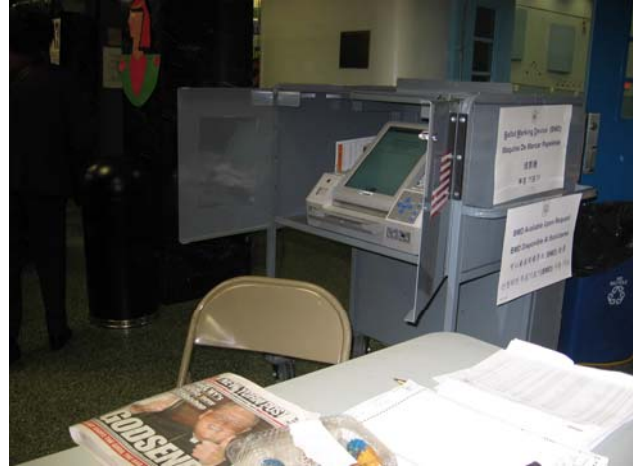
5. None of the poll workers were trained on the BMD. One poll worker said that the BMDs were a waste of tax payer money. She also said they were too complicated. The BMD was placed so that a voter would not have had privacy while using it. This underscores the need for poll worker training so they understand the reason for the BMDs and feel comfortable using them.
