**NOVEMBER 3, 2015 POLL SITE SURVEY SUMMARY REPORT**

**November 3, 2015 General Election**

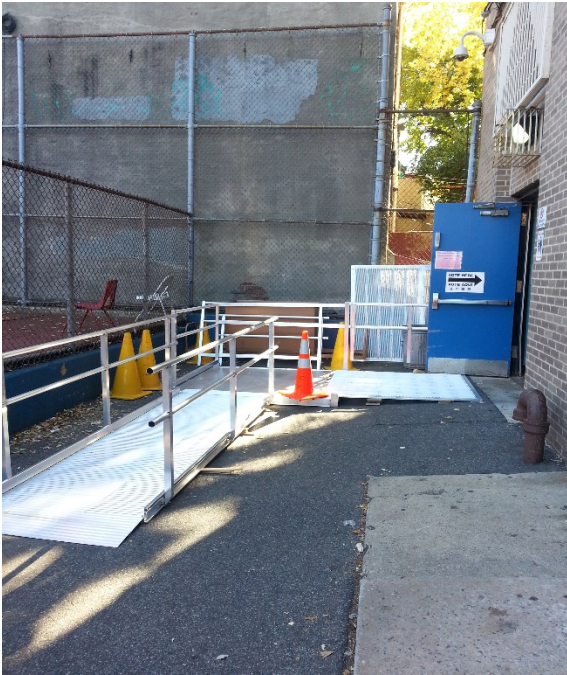
IS 302, Brooklyn –No side guards, presents tipping hazard for someone using a wheel chair.

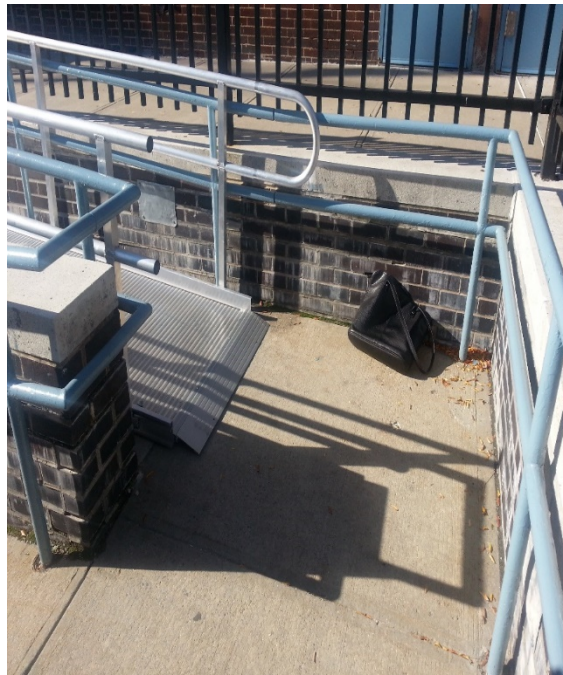
PS 224 Brooklyn- Bevel at entrance of ramp is too steep and shortens the turning radius making it difficult for a wheel chair user to negotiate the turn and use the ramp.

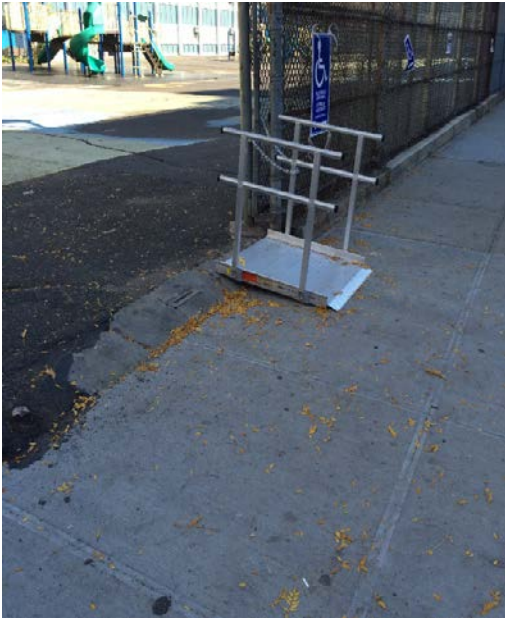
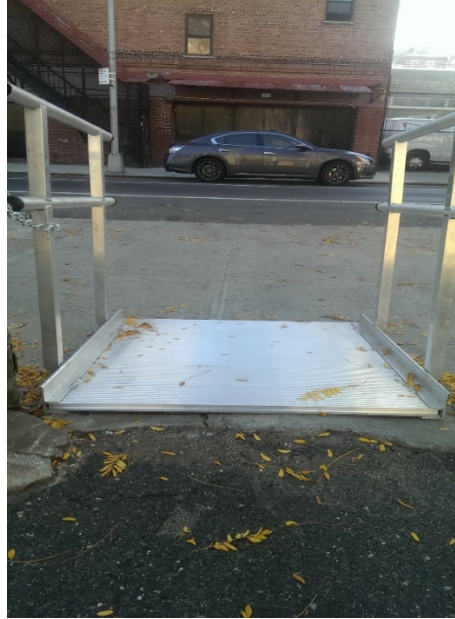
PS 154, Manhattan (left) - Ramp at alternate entrance looks like it is improperly installed and possibly unsteady. PS 154, Manhattan (right)- Ramp at alternate entrance exits on broken pathway potentially causing a tripping hazard for someone who is blind and a difficult or impossible landing for someone using a wheel chair.

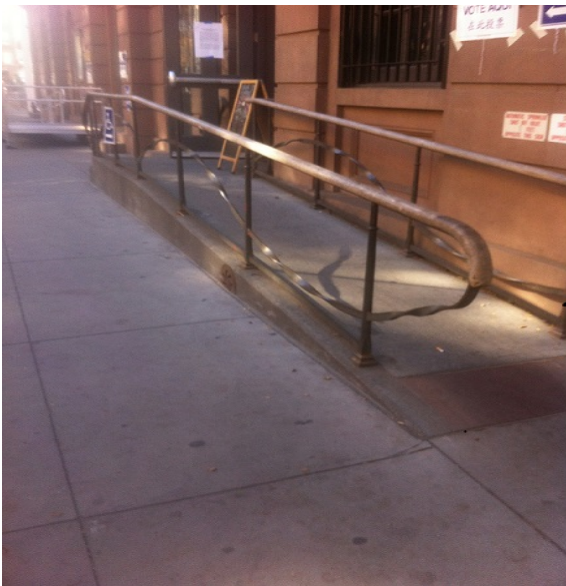
PS 47, Manhattan- The ramp had less than 5' turning space because of barrier placed at door.

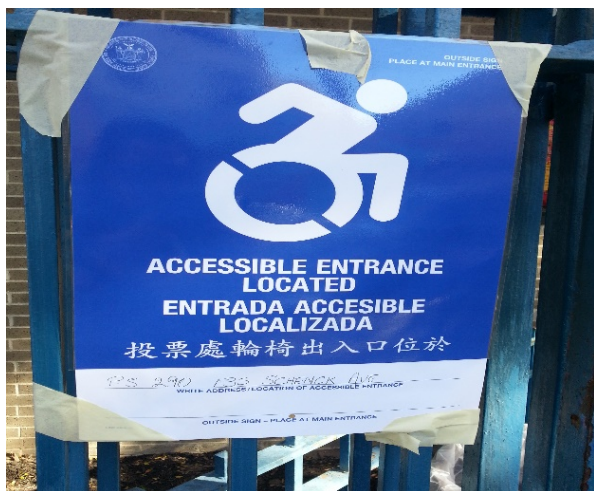
IS 302 Brooklyn- Wrong address on sign.

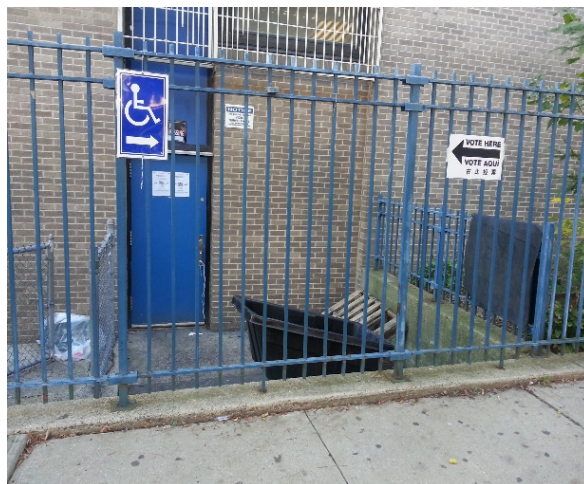
IS 302 Brooklyn- Directional arrows in the wrong direction.

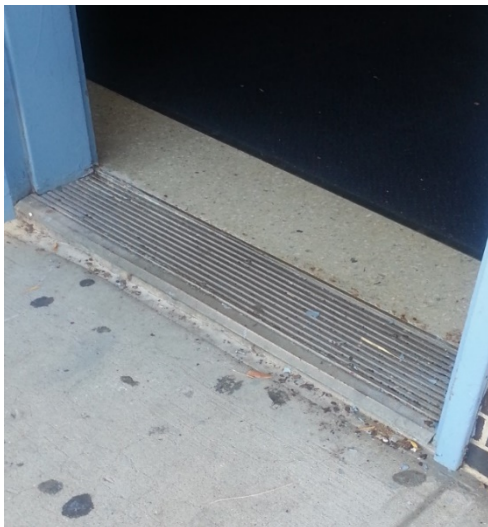
PS 224, Brooklyn- Lip at doorway is more than 1" high, presenting a tripping hazard and can be difficult for someone using a wheel chair to negotiate.

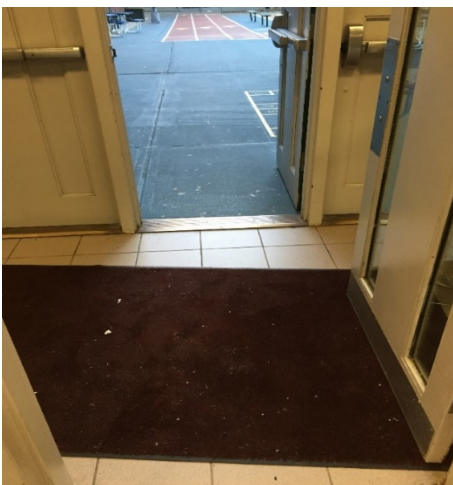
PS 57, Manhattan – Narrow doorway into voting area main entrance preventing its use by someone using a wheel chair or walker.

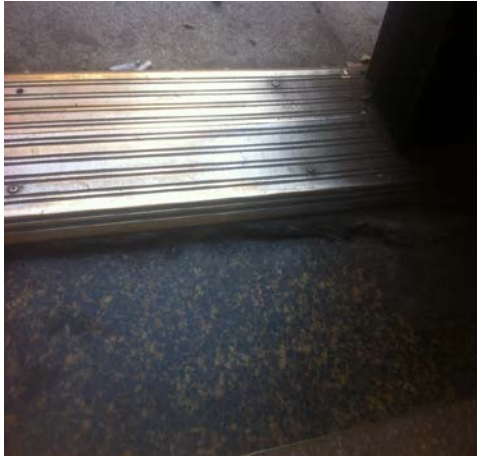
Bayard Rustin HS, Manhattan –

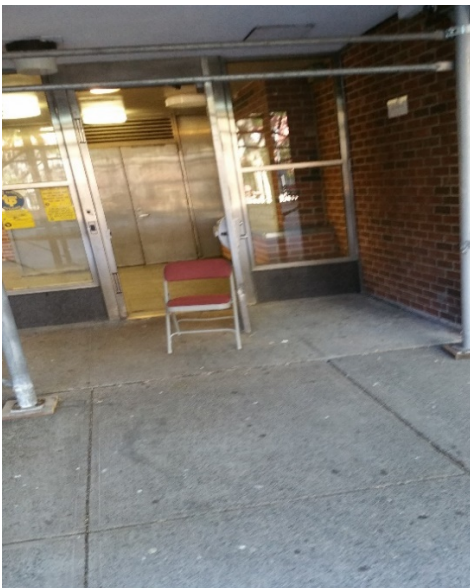
Max Meltzer Community Center, Manhattan-

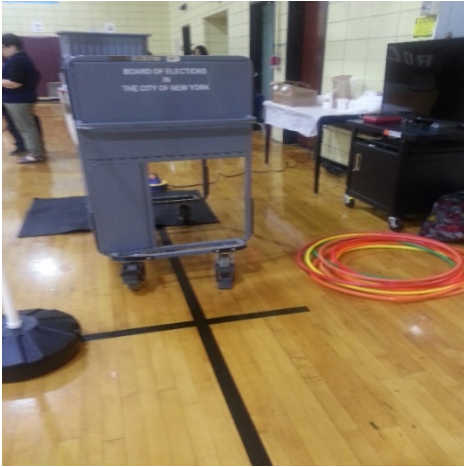
East New York High School, Brooklyn -Hoops obstructing BMD.
