November General Election 2017:

CIDNY teams surveyed a total of 59 sites during the November 7, 2017 General Election. Of the 59 sites surveyed only 24, or 40 percent, were without barriers.

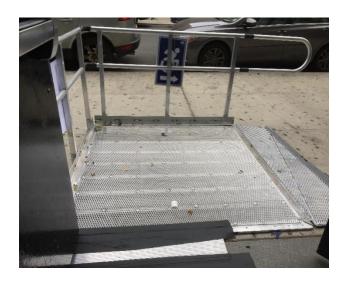
Rutgers Presbyterian Church Manhattan. Ramp with steep slope.

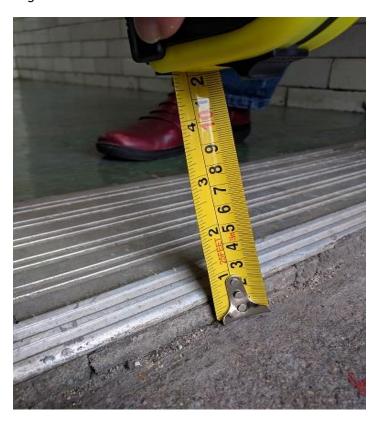
IS HS 70 333 West 18^{th} Street, New York, NY. The entrance door has a lip approximately 1 1/4" high with cracked cement.

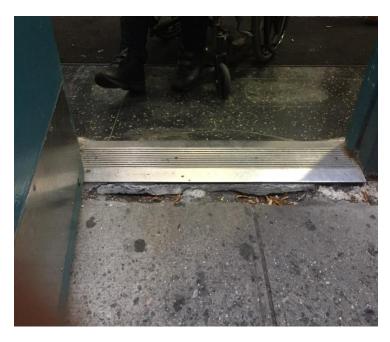
PS 130 Brooklyn. The pathway had a bad bevel that would not would be difficult for people with mobility issues to navigate.

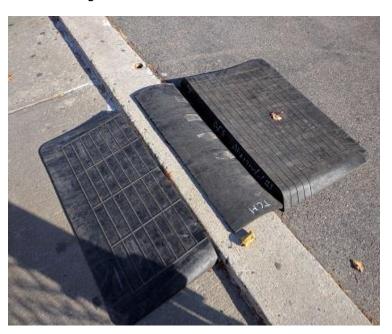
777 Concourse Village, Bronx. Broken sidewalk on the pathway to polling site.

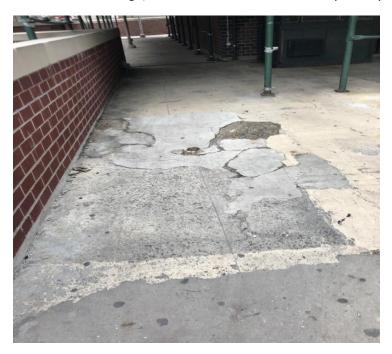
PS 41 Queens, cone used to keep door open blocks the entrance.

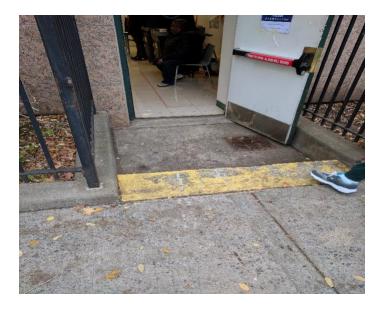
Crown Heights Library, Brooklyn – The lip at the entrance was too high and the door opening 31 $\frac{1}{2}$ inches wide.

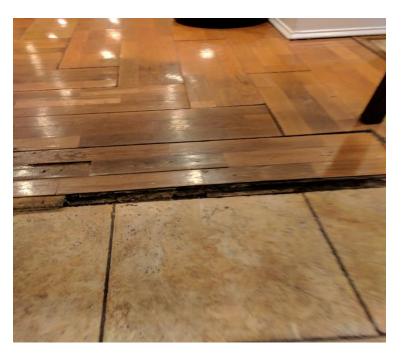
United Methodist Church - Pile of items near elevator exit, was in pathway from elevator into voting area.
